# Manhole Inspection Summary

Manhole # S35KK1001MH

Insp Date: **3/12/07 10:34 AM**

**Location** Address: **4303 UNDERWOOD RD**

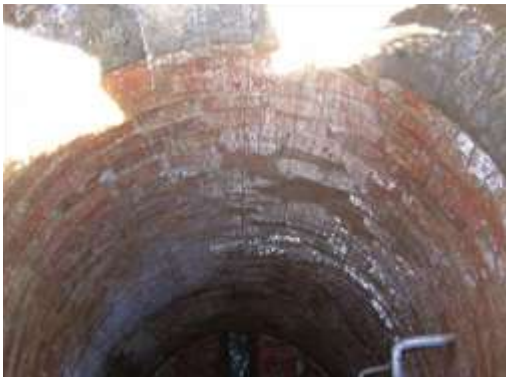
Defect

Adjustment, Corbel and Barrel infiltration.

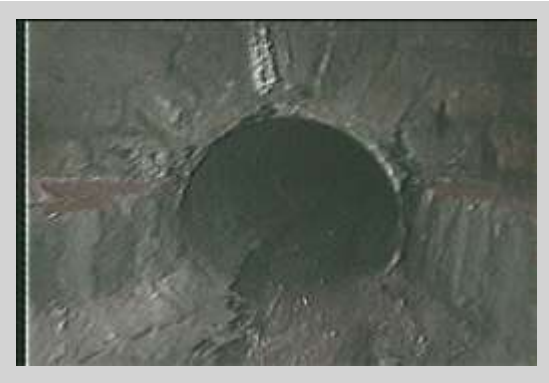
### 10 in. Circular Gravity Sewer Pipe Out @ 12 O'Clock

Infiltration: **Evidence** Pipe Seal Cond: **Unknown**

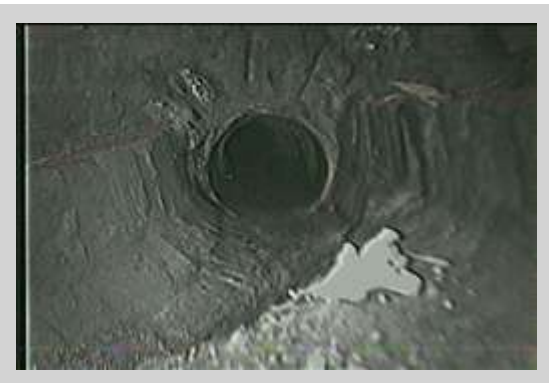
### 6 in. Circular Gravity Sewer Pipe In @ 3 O'Clock

Barrel deterioration and infiltration.

Infiltration: **Evidence** Pipe Seal Cond: **Unknown**
